Hauxley Mine Water

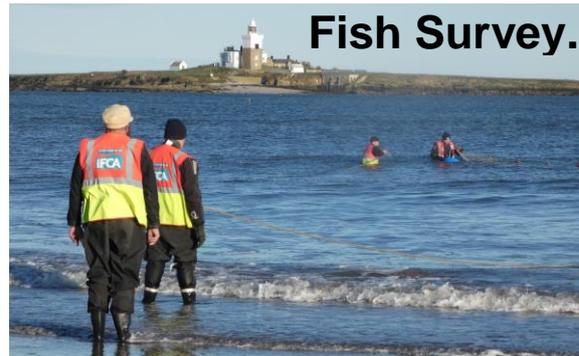
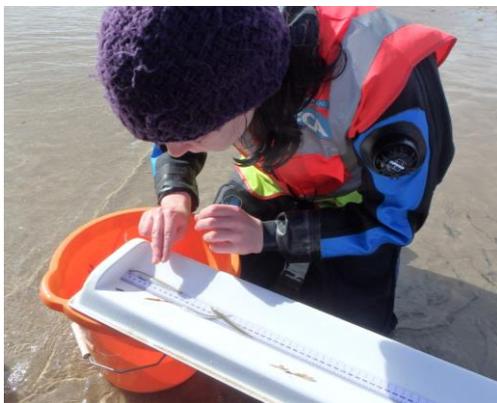
During each of the surveys the temperature, pH, salinity and percent of dissolved oxygen of the sea remained similar at each of the three sites. In July the temperature varied between 13.2 C to 14.0 C, pH 7.99 - 8.3, salinity 33.73 - 33.84 parts per 1000 and dissolved oxygen 99 -102. In September the temperature varied between 12.6 C to 12.8 C, pH 7.93 - 8.2, salinity 34.16 - 33.9 parts per 1000 and dissolved oxygen 94.8 -96.6. In December the temperature varied between 8.0 C to 8.4 C, pH 8.03 - 8.8, salinity 34.6 - 34.9 parts per 1000 and dissolved oxygen 101 -103. All these values are in line with other surveys conducted in the area and do not indicate anything out the norm.

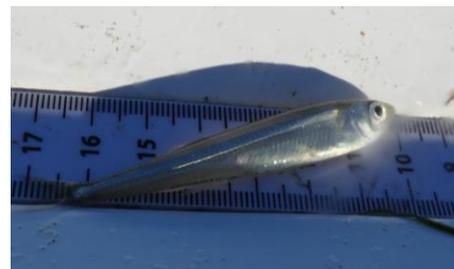
With regards to the fish surveys these were carried out to assess if the discharge would have an impact on the numbers of common fish species. During the first two sets of surveys the main species caught at all sites were Herring, Sprat and Sandeel and the quantities of these species remained similar at each of the sites. During the December survey sprat and herring were abundant at the first two sites surveyed. While at the site of the discharge the main species was sand smelt. As this

species requires similar conditions to herring and sprat it is unlikely the discharge is responsible for the lack of herring and sprat. All three of these species form tight shoals and it is not uncommon to catch predominantly only one species during surveys.
